Vehicle: 4064

Component: Diesel engine

Diagnosis date: 3 may 2013

Oil : Total Rubia Tir 8900 10W40

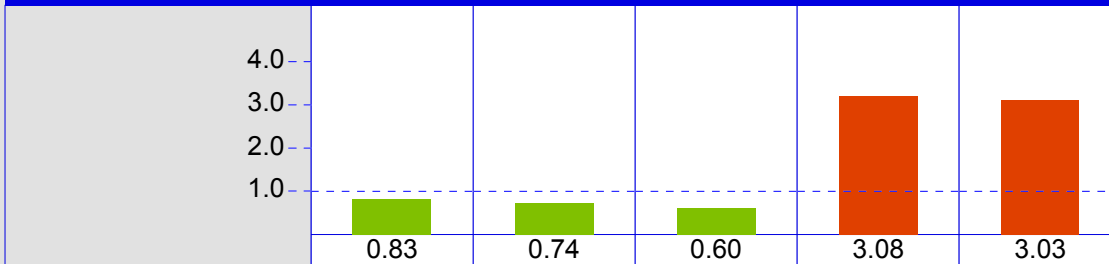
Wear coefficient

Element	Unit	30-NOV-11	06-MAR-12	02-JUL-12	29-OCT-12	21-FEB-13
Iron	ppmc	43	34	23	117	126
Lead	ppmc	2	< 1	< 1	< 1	2
Copper	ppmc	2	1	< 1	7	17
Tin	ppmc	< 1	< 1	< 1	< 1	2
Chromium	ppmc	1	1	< 1	8	8
Aluminium	ppmc	4	5	4	11	13
Nickel	ppmc	< 1	< 1	< 1	2	2

- Increase of the viscosity at 100°C in comparison with the indicated oil type.
