# **Papua LNG Project – Downstream**

## **Nearshore Marine Baseline**

ExxonMobil PNG Antelope Limited

**Reference: 754-MELEN300733\_R03**

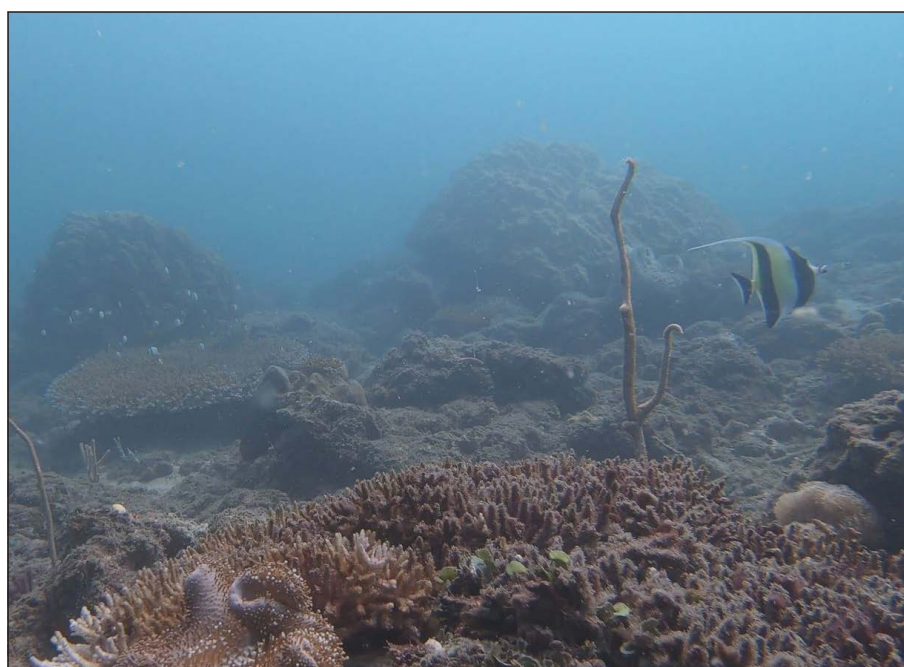
**Plate 6.82**  
Benthic habitat at CF-11 showing degraded reef,  
moorish idol (*Zanclus cornutus*), patchy coral  
and small damselfish (*Dascyllus* sp.)

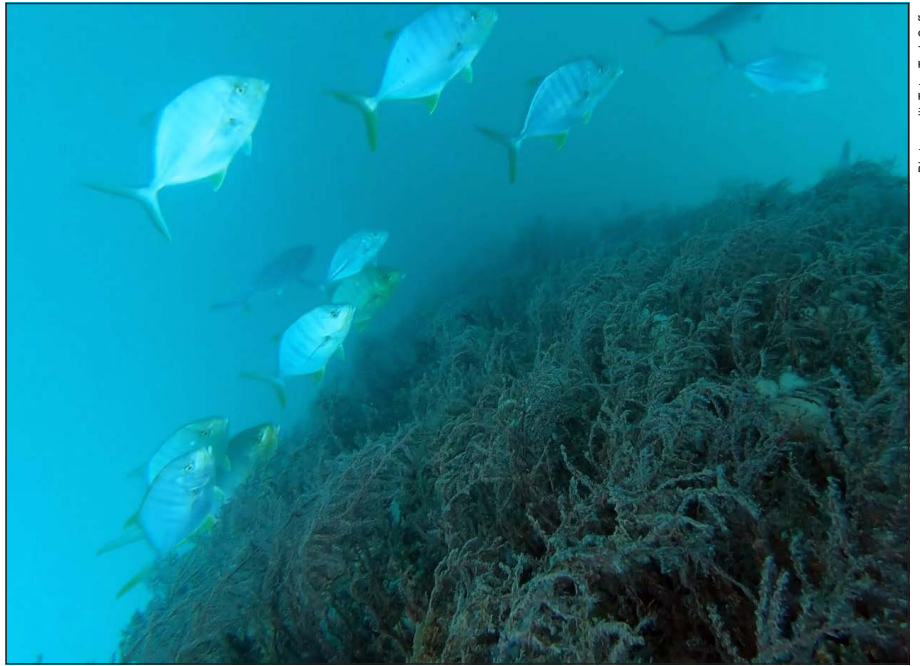
**Plate 6.88**  
Schooling fish (trevally) and macrophyte  
colonisation at LNG Plant jetty pylon

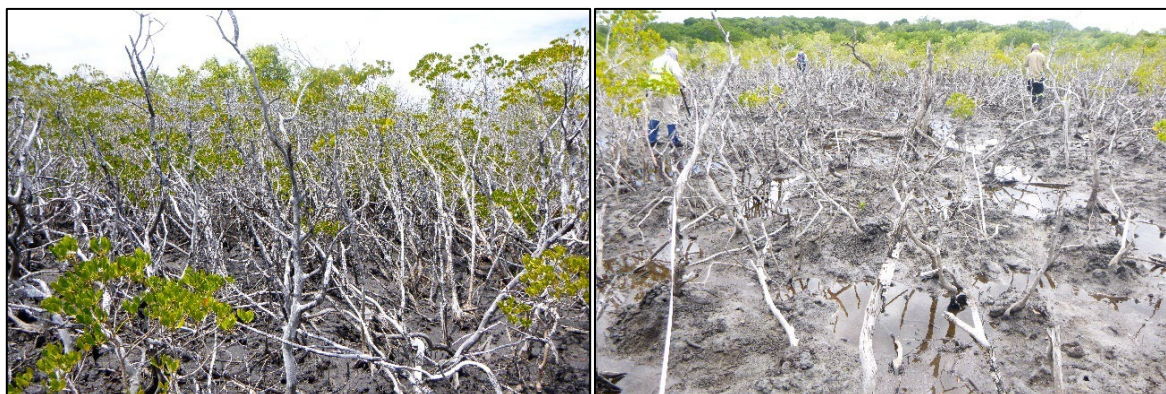
**Figure 13.** Evidence of mangrove dieback around transects, with ponding and stagnant water present.

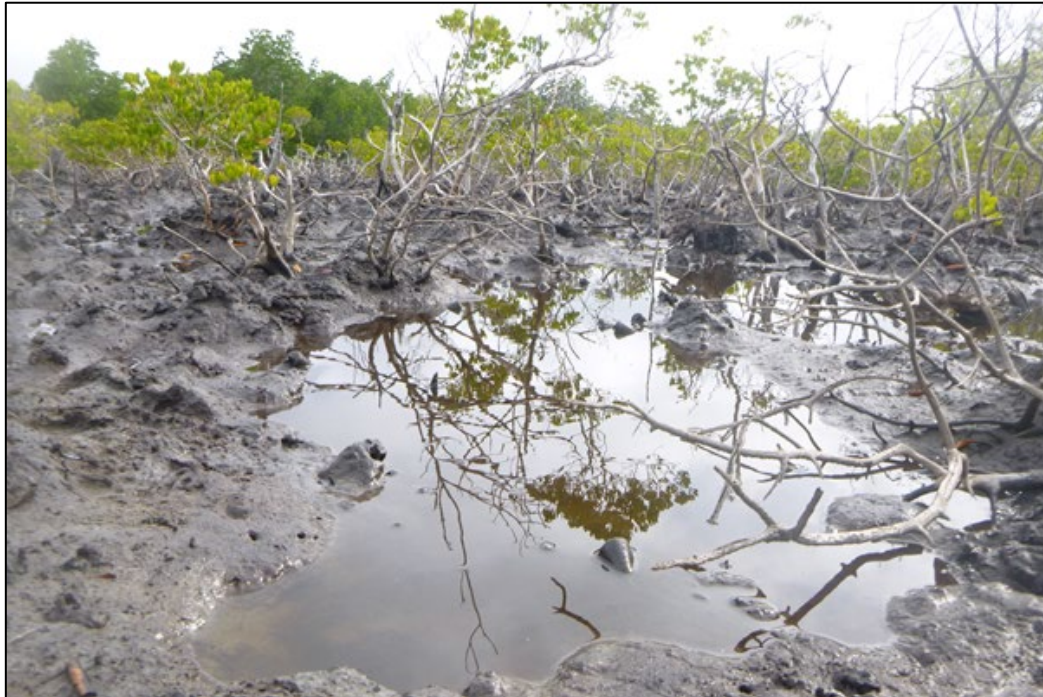
**Figure 19.** Site WQ8 with brackish water and associated mangrove dieback. Image shows evidence of sink centres.

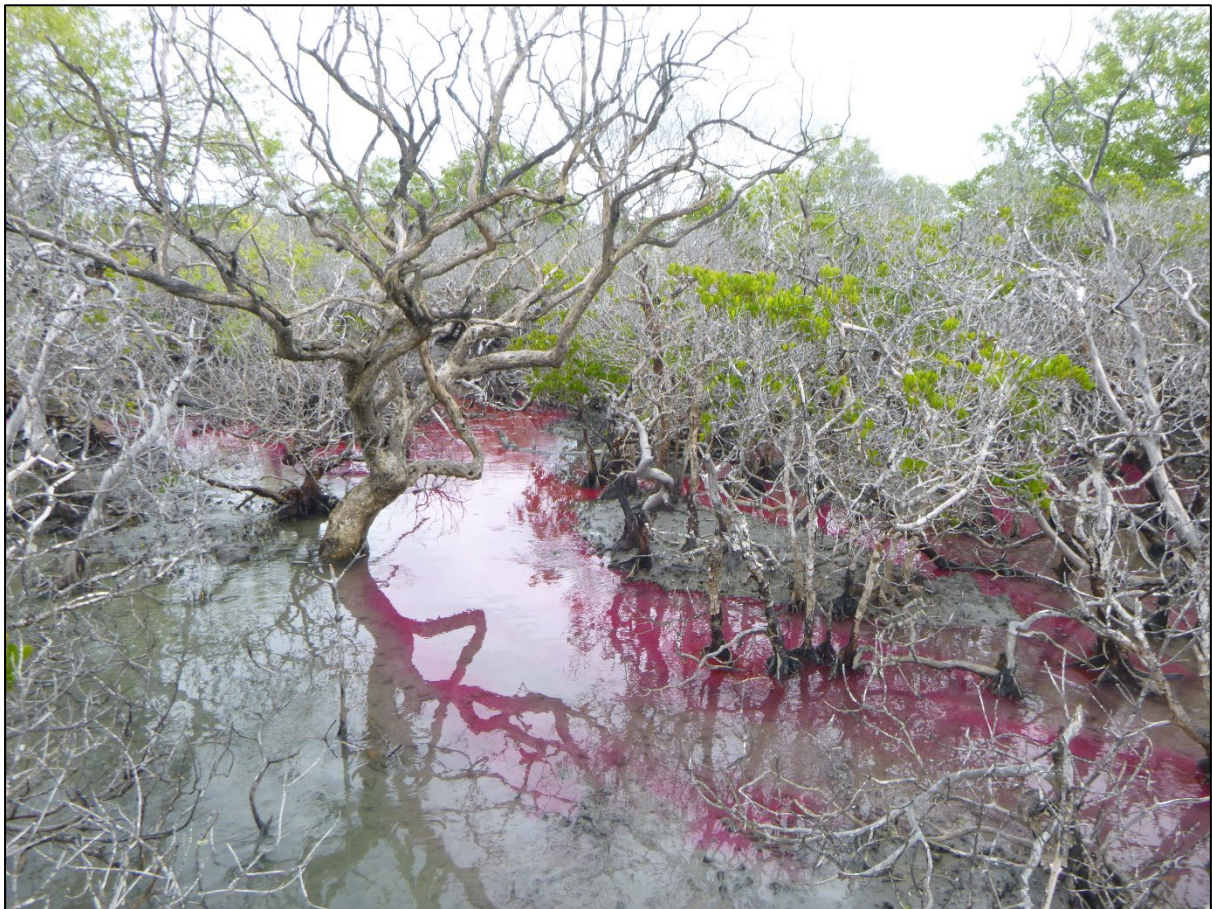
**Figure 25.** Rhodamine WT travelling to a dieback area from Release Point I (Mixing ponds).

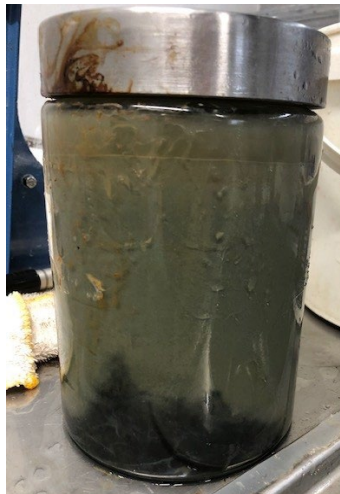
Figure 1: Samples jar of site SED32 with anoxic base.
