TILENGA PROJECT

ENVIRONMENTAL AND SOCIAL IMPACT ASSESSMENT

Volume VI(b)

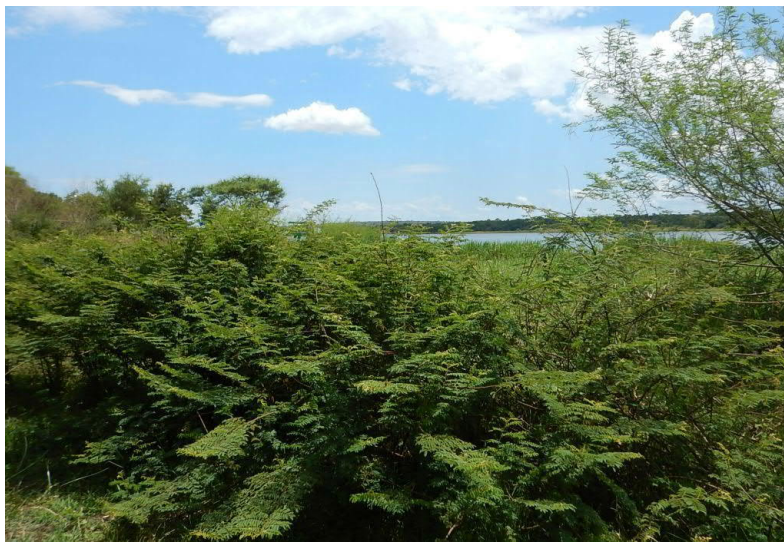
Photo A-JK-170419-561 of invasive *Mimosa pigra*

- Three invasive species of plant were recorded in the site, viz: *Salvinia molesta* and *Eichhornia crassipes* (Photo A-JK-170419-545) at low abundance and *Mimosa pigra* (Photo A-JK-170419-561) at moderate level of abundance. The first two species are purely aquatic species that will not grow on dry ground but the later may survive in environments that are only hygrophic but not dry. These species have the potential to spread with disturbance. Construction activity of the Victoria Nile Ferry Crossing point may cause siltation into the river proliferating the incidence of the three species.

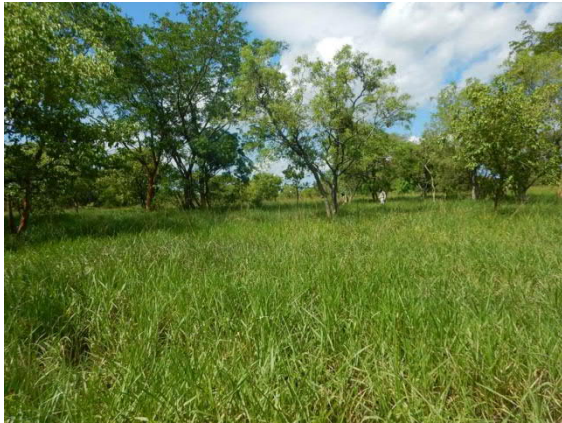
Photo A-JK-170419-524 of Woodland with dense ground grass cover

This site is located within well wooded vegetation with moderate to tall grass. There is hardly any bare ground owing to a very good cover of the ground by grass (Photo A-JK-170419-524). The vegetation is Woodland dominated by *Albizia*, *Acacia* and *Philenoptera* in the tree layer with *Combretum molle*, *Securidaca longipedunculata* and *Stereospermum kunthianum* in the shrub layer and *Brachiaria*, *Hyperthelia* and *Hyparrhenia* in the herbaceous layer forming a dense cover with moderate height; on sandy soil. *Albizia grandibracteata*, *Acacia sieberiana* and *Philenoptera laxiflora* are dominant in the woody layer of the woodland while *Brachiaria brizantha*, *Hyperthelia dissoluta* and *Hyparrhenia filipendula* are the dominant grass species.

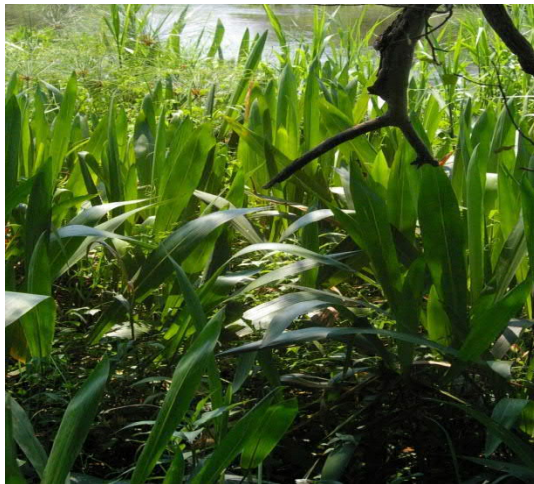
Photo X2 *Suddia sagittifolia* recorded from the Victoria Nile margins

- *Suddia sagittifolia*, which is an aquatic grass species of restricted range (known only from the Nile by the Lake Kyoga area in Uganda as the southern-most limit of its geographical range (Kalema 2005) to South Sudan (Renvoize *et al.* 1984)), was not recorded but is likely to occur along the Victoria Nile around the site. It grows in *Cyperus papyrus* mats at the river margins with *Typha domingensis* and *Vossia cuspidata* and *Phragmites mauritianum* (Photo X2)

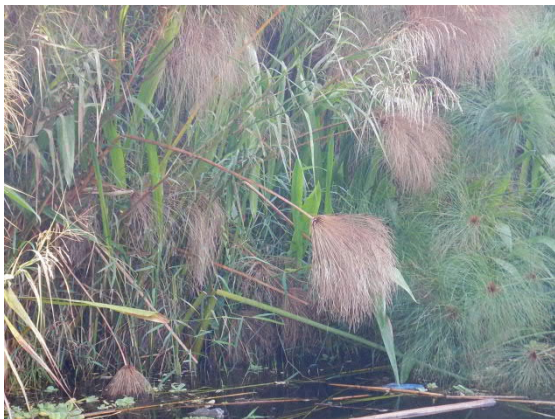
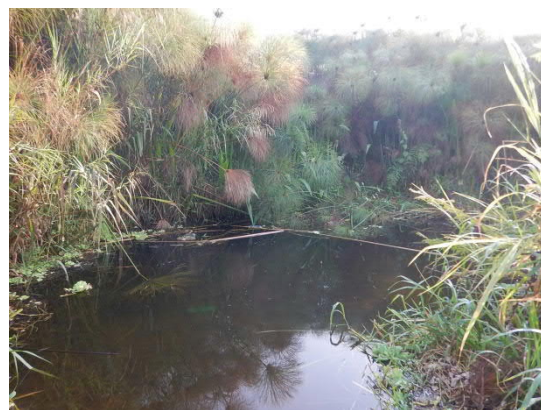
Photos of permanent swamp with *Suddia sagittifolia*, a restricted range species, A-JK-180117-769 and A - JK-180117-77.

Dalbergia melanoxyton, a Globally Threatened species (VU - IUCN 2017) was recorded at the site at very low abundance. The restricted range *Suddia sagittifolia* found in permanent swamp was also recorded.

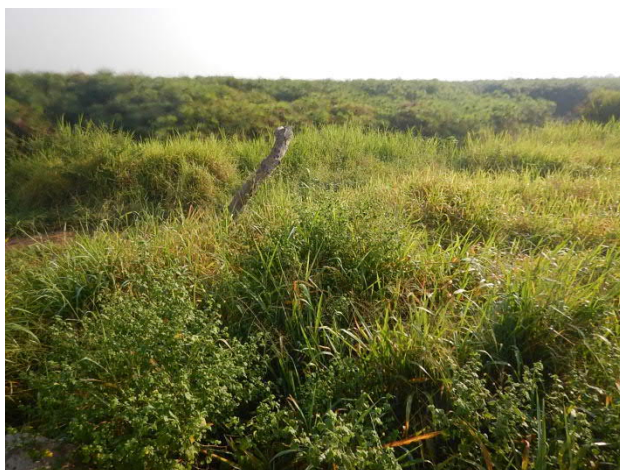
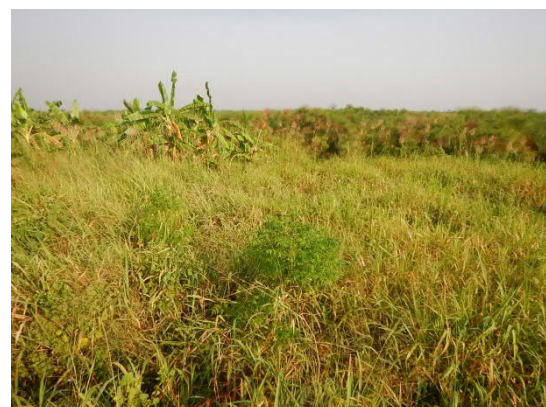
Photos of Papyrus swamp (permanent swamp) photos A-JK-180117-772 and A-JK-180117-774.

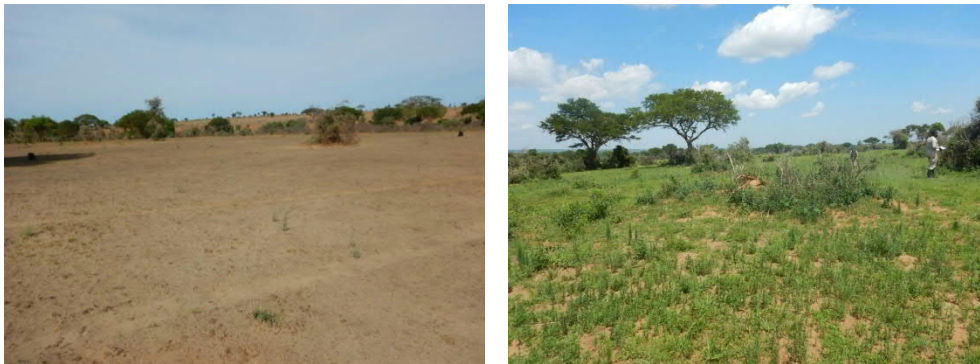
Photos A-JK-170409-275 and A-JK-170627-793 of Bushed Grassland and Grassland

This site is located on gently to moderately sloping ground on sandy soil. The vegetation is mainly Open Grassland (Photos A-JK-170409-275 and A-JK-170627-793) with *Acacia-Balanites* Open Wooded Grassland along the vale with *Acacia sieberiana* and *Harrisonia abyssinica* in the shrub layer with short grass.

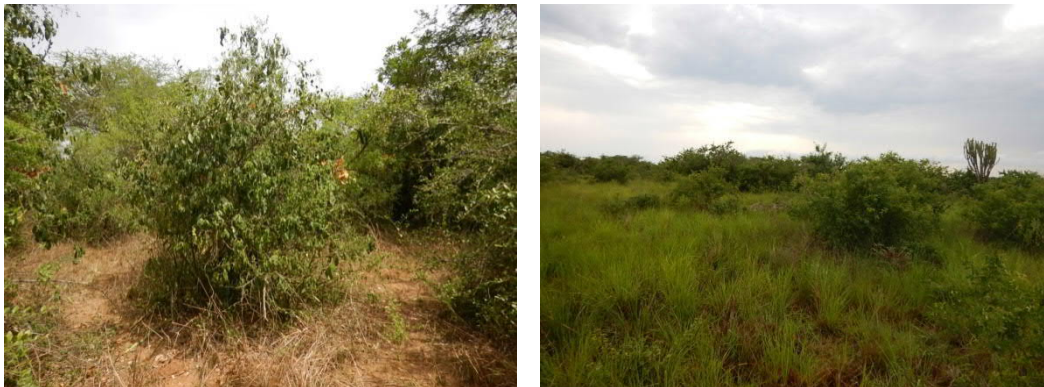
Photos A-JK-170417-438 (left) and A-JK-170625-749 (right) with Bushland and Bushed Grassland

This site is located on flat ground (Photos A-JK-170417-438 and A-JK-170625-749) on sandy soil. The vegetation is mainly a Bushland-Bushed grassland mosaic dominated by *Acacia sieberiana* trees (Photos A-JK-170417-438 and A-JK-170625-749). In places, the vegetation becomes Dense *Acacia* bushland with *Vepris* and *Capparis* in the shrub layer with a sparse herbaceous layer. *Harrisonia abyssinica*, *Cadaba farinosa*, *Combretum aculeatum*, *Maytenus undata* and *Capparis fascicularis* are the commonest and dominant species in thicket and Bushed Grassland communities. The grass is short grass (under c.0.5 m).

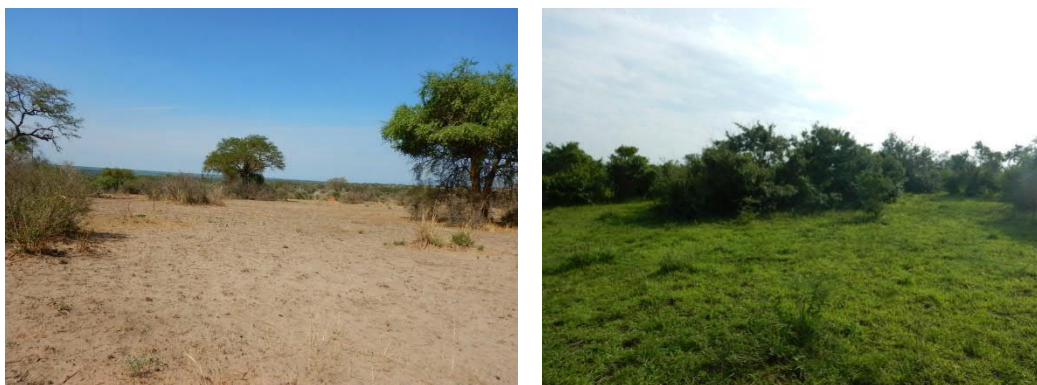
Photos A-JK-170410-307 and A-JK-170623-735 of Grassland with Thicket and Bushed Grassland

This site is located on moderately sloping ground with slope angle of 8-16° on sandy soil. The vegetation is composed of Open Grassland with Thicket and occasional trees of *Balanites aegyptiaca*. There is also open *Acacia* Wooded Grassland along the vale. In some places there is Bushed Grassland with *Harrisonia abyssinica* and *Acacia sieberiana* and occasional tree cover of *Balanites aegyptiaca* and *Acacia sieberiana* with virtually no grass layer in the dry season due to burning. The grass is short (under c.0.5 m) due to grazing. (Photos A-JK-170410-307 and A-JK-170623-735)

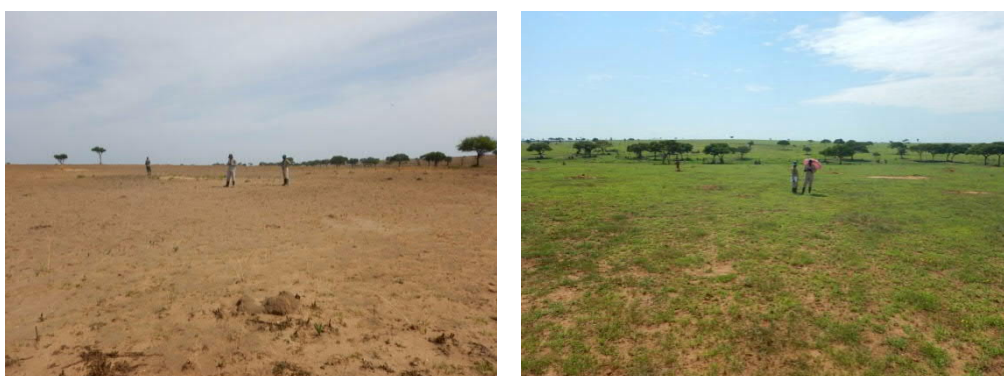
Photo A-JK-170411-325 (left) and A-JK-170628-805 (right) of Open Grassland at JBR-03 in dry season (left) and in wetter season (right)

This site is located on well drained sandy soils sloping ground angle mostly 16-32° on sandy soil. The vegetation is mainly Open Grassland dominated by *Hyperthelia dissoluta*; *Bulbostylis* sp., *Chamaecrista kirkii* and *Sporobolus stafianus* with very sparse tree cover of *Crateva* and very short grass during drought periods and also due to burning. In the surrounding vales is Acacia Wooded Grassland.

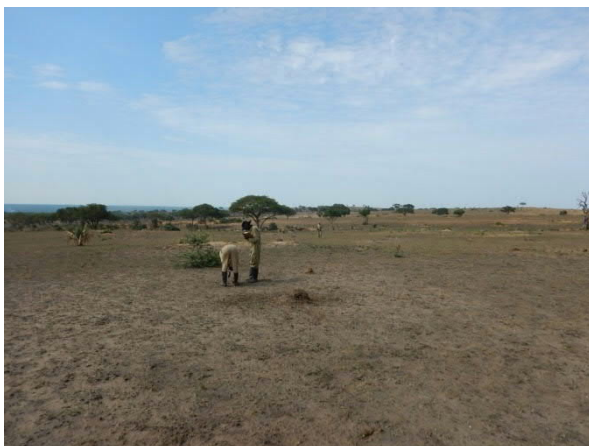
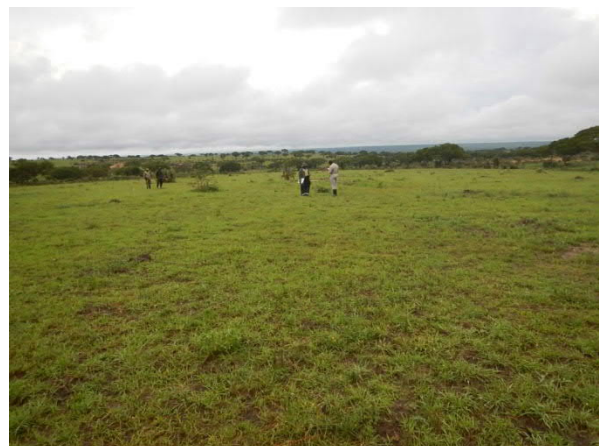
Photos A-JK-170412-338 and A-JK-170629-820

This site is located on gently sloping terrain (slope mostly 8-16°) on sandy soil. The vegetation is mainly Open grassland with very sparse tree cover of *Acacia* with short grass due to burning and drought (Photos A-JK-170412-338 and A-JK-170629-820). In the surrounding vale is Seasonally Flooded Open *Acacia* Wooded Grassland with sparse bushes of *Harrisonia abyssinica* and short grass during the dry season. The herb layer is dominated by *Hyperthelia dissoluta*, *Ctenium newtonii* and *Eragrostis* sp. fringed by *Acacia sieberiana* Open Wooded Grassland.

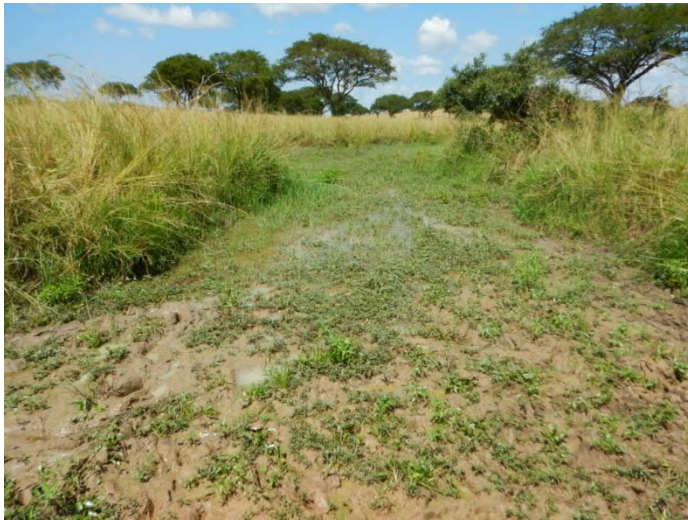
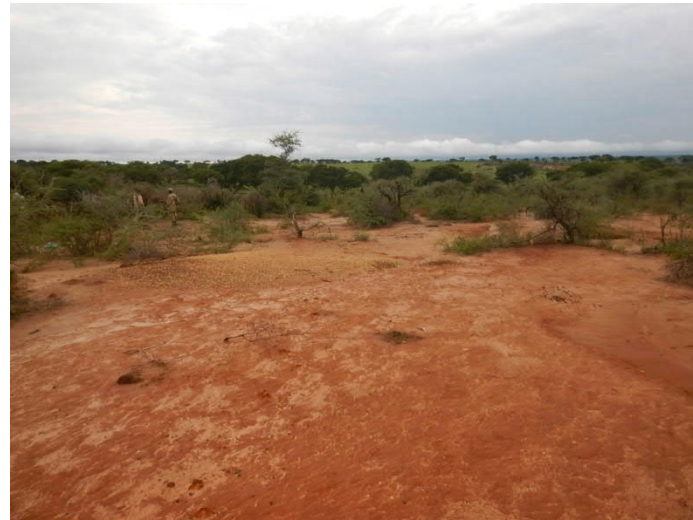
Photo A-JK-161124-089 of seasonal wetland with habitat-specific flora (left) and A-JK-170629-823 with friable soils

No species of conservation concern were recorded at this site. However, there are notable avoidance features recorded within the site as mature large trees, particularly of *Acacia sieberiana* and *Balanites aegyptiaca*. In addition, there are seasonally flooded wetland areas (Wetland with seasonal water presence) with habitat-specific flora such as *Nymphaea lotus*, *Caldesia resinosa*, *Cyperus iria*, *Sphenoclea zeylanica* (Photo A-JK-161124-089) and friable soils with marginal plant species (Photo A-JK-170629-823). These are azonal habitats enhancing alpha and beta diversity.

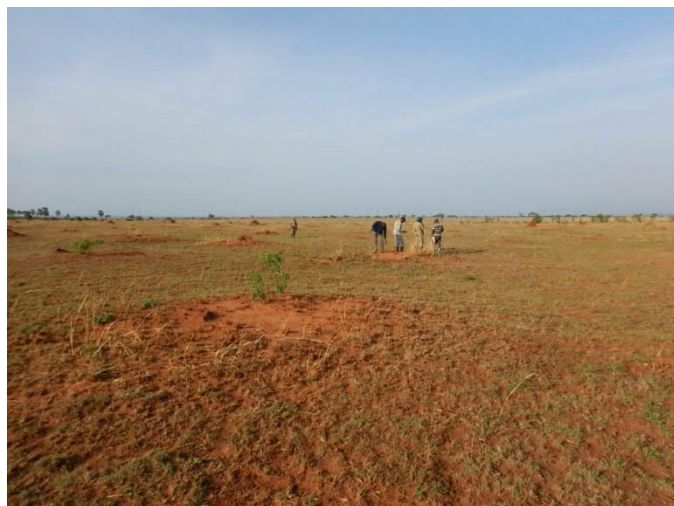
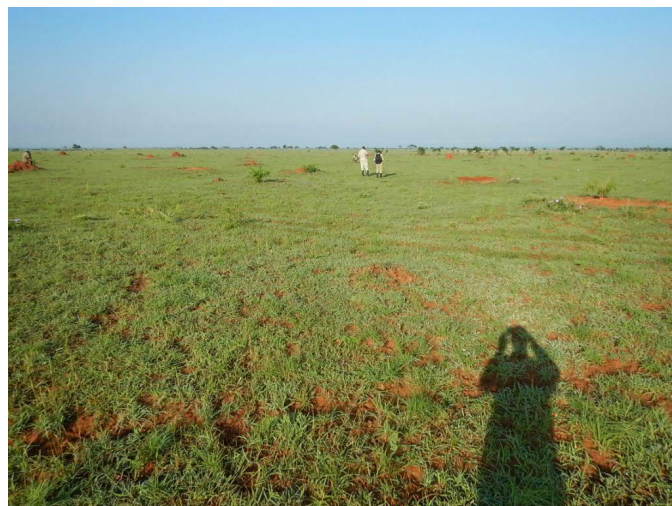
170630-843

This site is located on flat ground, slope 0-8° on sandy soil. The vegetation is Open *Hyperthelia*, *Ctenium*, *Eragrostis* and *Bulbostylis* grassland with sparse *Crateva adansonii*, *Borassus aethiopum*, and *Acacia sieberiana* tree cover and short grass on sandy soil (Photo A-JK-170413-351 and A-JK-170630-843). In small patches are *Crateva* or *Borassus* Open Wooded areas.

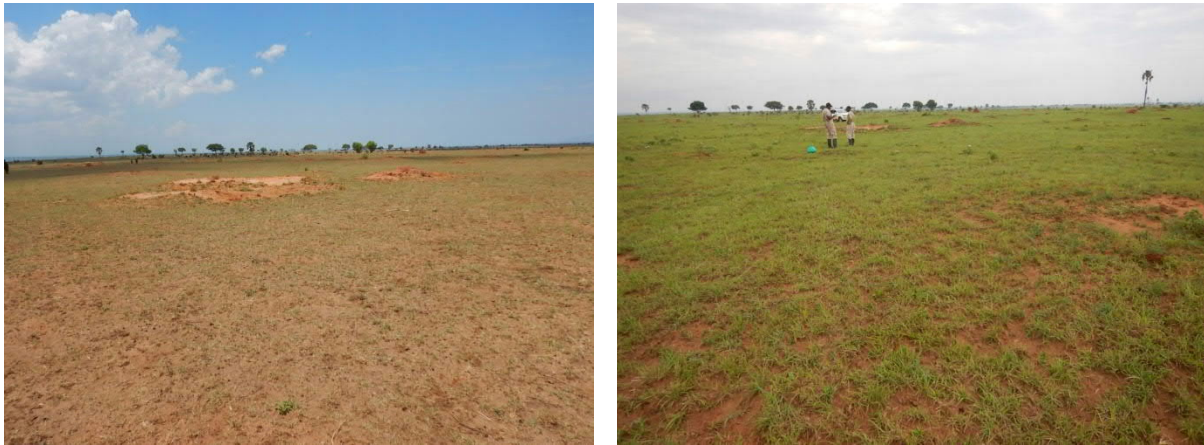
Photos A-JK-170413-375 and A-JK-170701-868 of Open Grassland

This site is located on ground that is flat or gently sloping (4-8°) to moderate slope (16-32°) on sandy soil. The vegetation is Open Grassland dominated by *Hyperthelia dissoluta* and *Digitaria longiflora* with very sparse *Borassus aethiopum* and *Crateva adansonii* tree cover and very short grass on sandy soil (Photos A-JK-170413-375 and A-JK-170701-868). Open grassland dominated by bare eroded gullies fringed by *Acacia* and *Balanites* trees in vale and very sparse grass cover on gritty sandy soil. In the surrounding vale is sparse *Borassus* cover with *Hyperthelia* and *Sporobolus pyramidalis*.

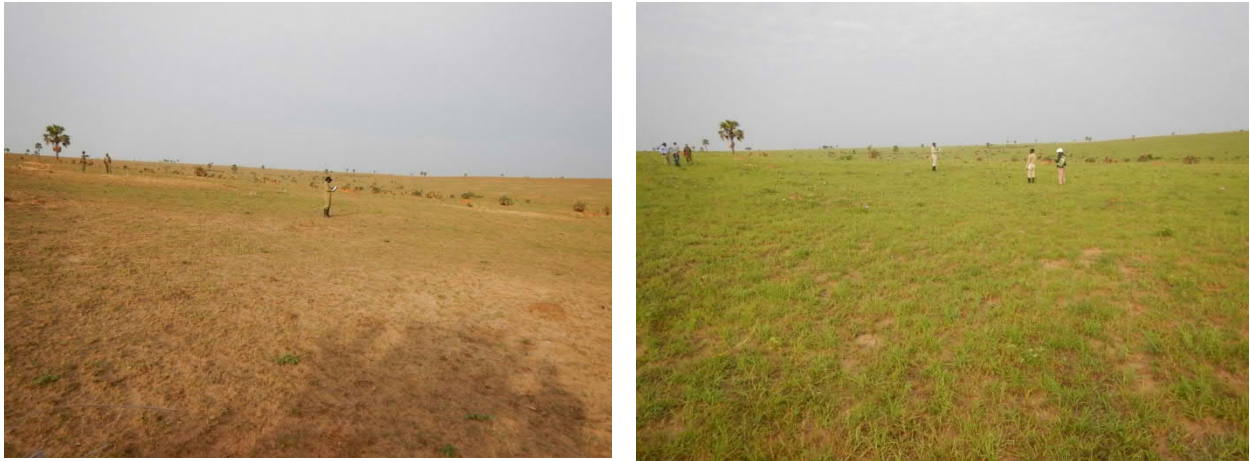
Photos A-JK-170414-382 and A-JK-170703-892 of Open Grassland

This site is located on sloping ground (slope 8-32°) on sandy soil. The vegetation is mostly Open Grassland with sparse *Borassus* tree and shrub and occasionally *Balanites aegyptiaca* and *Crateva adansonii* cover and very short grass due to drought and over grazing (Photos A-JK-170414-382 and A-JK-170703-892). The herb layer is dominated by *Hyperthelia dissoluta*, *Eragrostis* sp. and *Ctenium newtonii*.

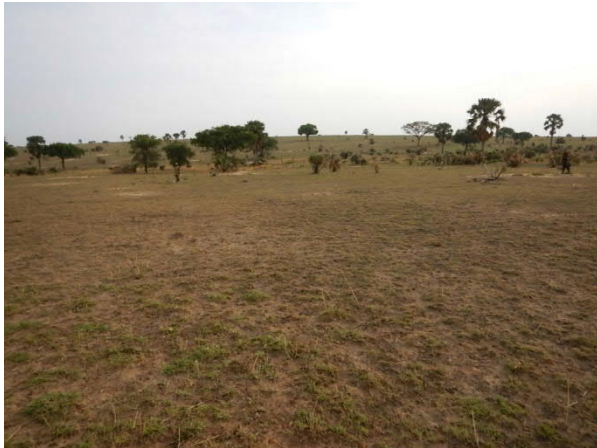
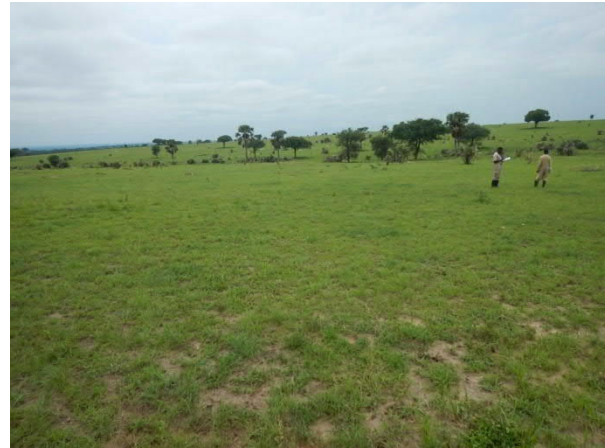
Photos A-JK-170415-396 and A-JK-170704-915 of Open Grassland with *Borassus* and *Balanites*

This site is located on gently to moderately sloping ground (slope ranging 8-32°) on sandy soil. The vegetation is mainly *Hyperthelia* Open Grassland with sparse *Borassus* and *Balanites* tree cover and occasional presence of mature *Acacia sieberiana* trees (Photos A-JK-170415-396 and A-JK-170704-915).

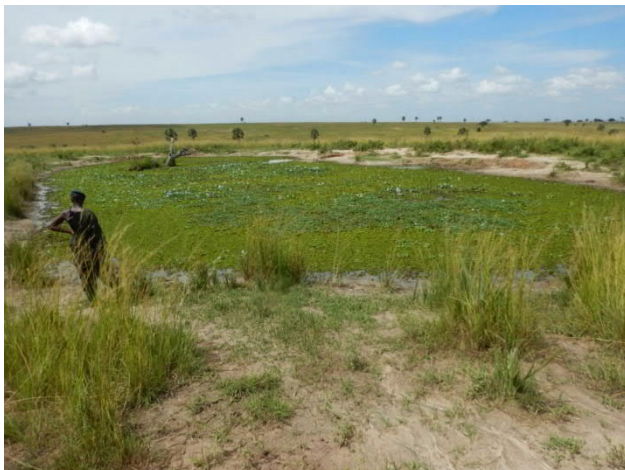
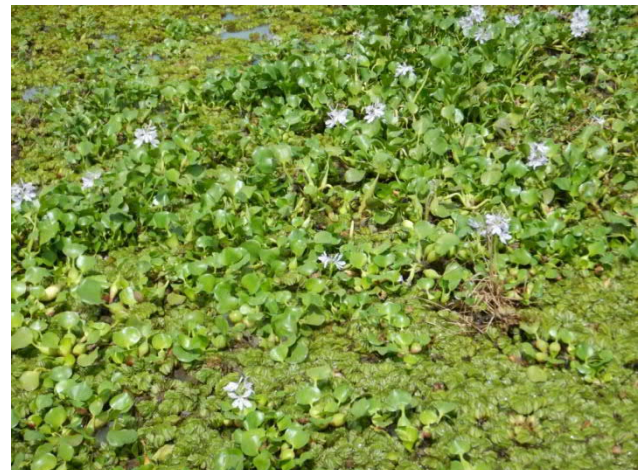
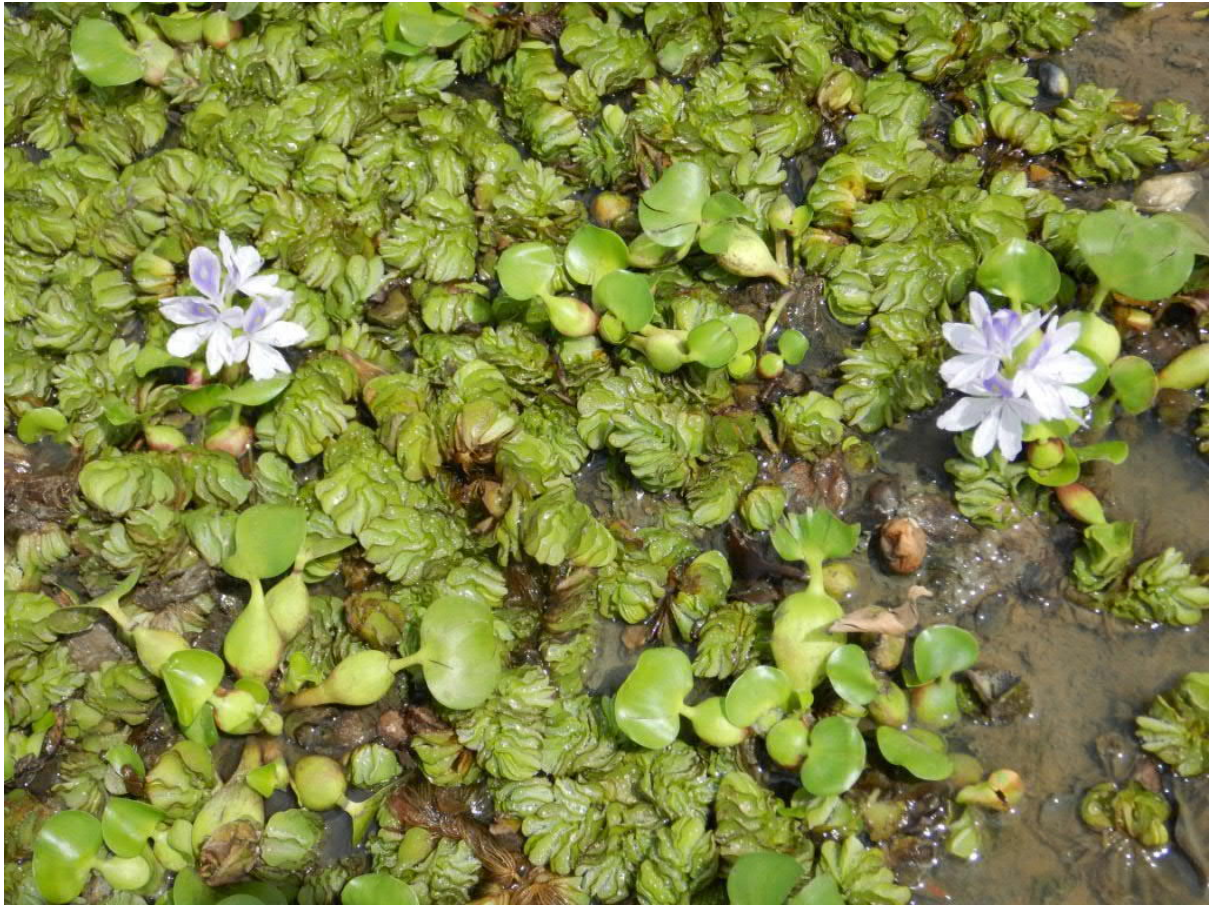
Photos A-JK-161129-193 (top left), A-JK-161129-195 (bottom) and A-JK-161129-196 (top right) of invasive *Salvinia molesta* and *Eichhornia crassipes*

No threatened, rare or range-restricted species recorded at the site. However, there are two invasive plant species, viz: *Salvinia molesta* and *Eichhornia crassipes* in a wetland (Photos A-JK-161129-193, A-JK-161129-195, A-JK-161129-196 that could proliferate with disturbance.

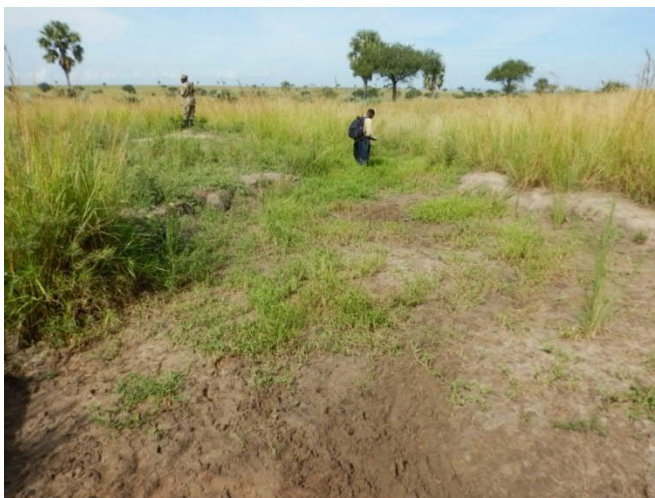
Photo A-JK-161129-186 of seasonal wetland

No species of conservation concern were recorded at this site. However, there are notable avoidance features recorded within the site as mature large trees, particularly of *Borassus aethiopum*, *Crateva adadnsonii*, *Balanites aegyptiaca* and *Acacia sieberiana*. In addition, there is seasonally flooded *Urochloa* seasonal wetland with habitat-specific flora in a wallow at the site (Photo A-JK-161129-186).

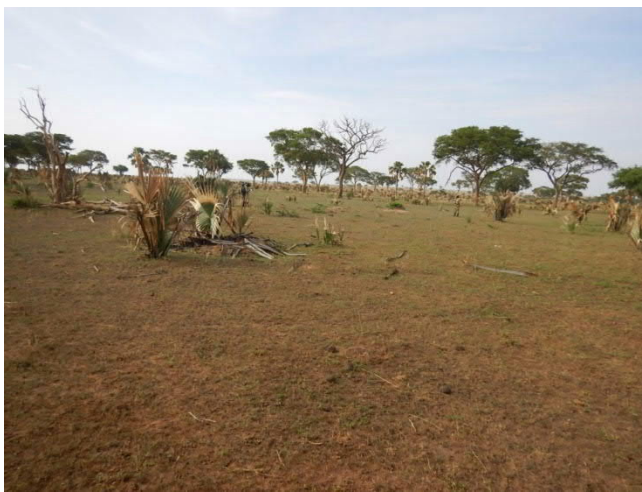
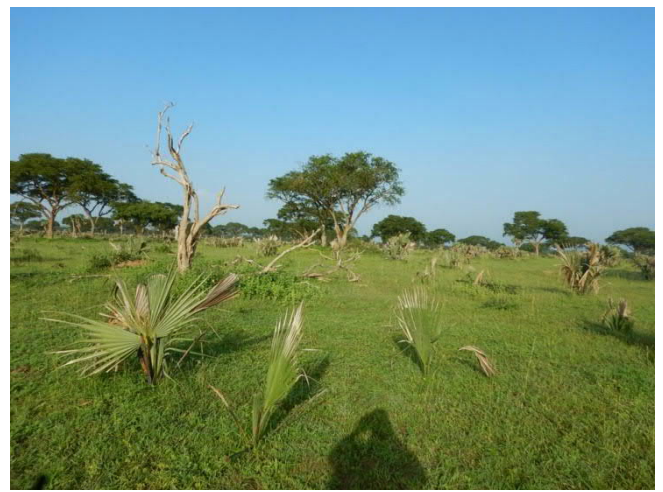
Photos A-JK-170416-412 and A-JK-170626-

760 of *Borassus-Acacia* Wooded Grassland

This site is located on flat ground (slope 4-8°) on sandy soil. The vegetation is *Borassus-Acacia-Balanites-Hyperthelia* Wooded Grassland with *Borassus* in the shrub layer and very short grass due to over grazing and burning at the well site (Photos A-JK-170416-412 and A-JK-170626-760). This is surrounded by Open *Borassus-Acacia* woodland with *Borassus-Crateva* shrub layer and short grass due to burning and over grazing. In places, the vegetation becomes Open *Acacia* woodland with occasional *Borassus* trees and *Borassus* in the shrub layer and very short grass. In the adjacent gully is Open Riverine Woodland dominated by *Acacia* and *Borassus* in the tree layer with *Sporobolus* and *Setaria* in the herb layer with moderate grass height.

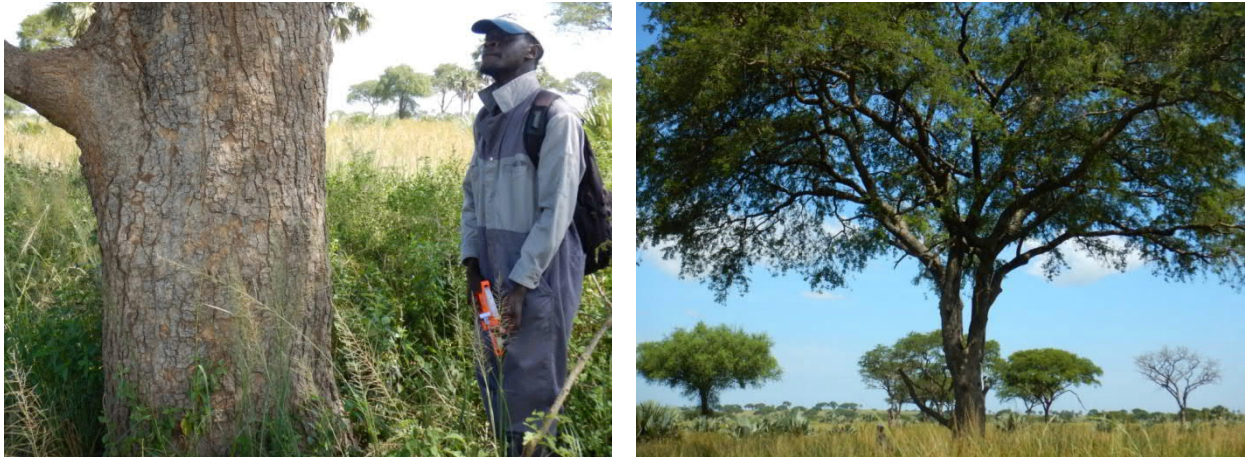
Photos A-JK-161130-211 and A-JK-161130-212 of large mature *Acacia* tree

No species of conservation concern were recorded at this site. However, there are notable avoidance features recorded within the site as mature large trees, particularly of *Acacia sieberiana* (Photos A-JK-161130-211 and A-JK-161130-212), *Borassus aethiopum* and *Balanites aegyptiaca*.

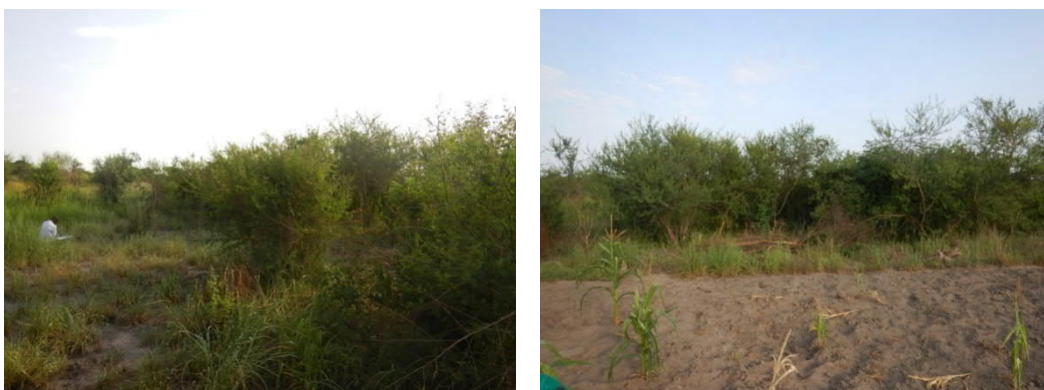
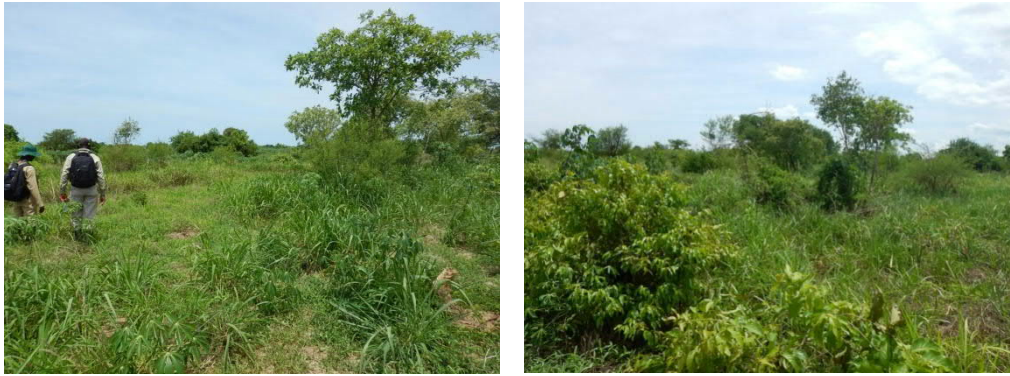
Photos A-JK-170613-589 and A-JK-170613-590 of Bushed Grassland with cultivation (above) and A-JK-170421-584 and A-JK-170421-585 (below) of Bushed Grassland relics in cultivation (below)

The well site is located on very gently sloping ground (slope 4-8°) on sandy soil. The whole environment is modified with cultivation, leaving only very few isolated mature trees. The vegetation at the well site itself is Bushed Grassland dominated by *Acacia hockii* and *Harrisonia abyssinica* with *Cyperus* sp., *Setaria sphacelata* and *Brachiaria brizantha* in the herb layer and partly cultivated with *Zea mays* (maize) and *Gossypium* (cotton) (Photos A-JK-170613-589 and A-JK-170613-590).

The surrounding area is mostly cultivated with *Manihot* gardens with relics of small trees and relics of *Lannea-Harrisonia-Ziziphus* thicket. There is occasional occurrence of *Musa* garden surrounded by *Grevillea* trees with weeds of cultivation such as *Digitaria ciliaris*, *Bidens pilosa*, *Commelina africana* and *Brachiaria scalaris* and *Brachiaria brizantha* in the herb layer. There are also Post-cultivation areas of *Manihot esculenta* and bushed grassland with *Albizia grandibracteata*, *Acacia hockii* and *Harrisonia abyssinica* with *Panicum maximum* in the herbaceous layer (Photos A-JK-170421-584 and A-JK-170421-585).

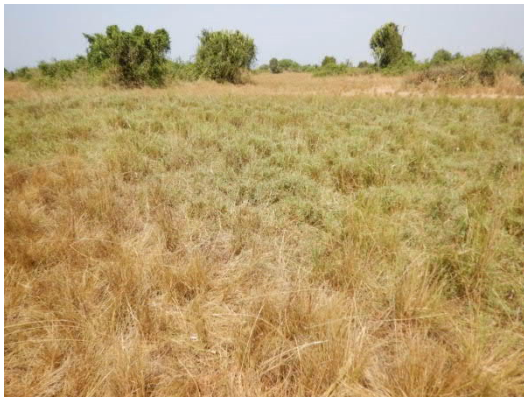
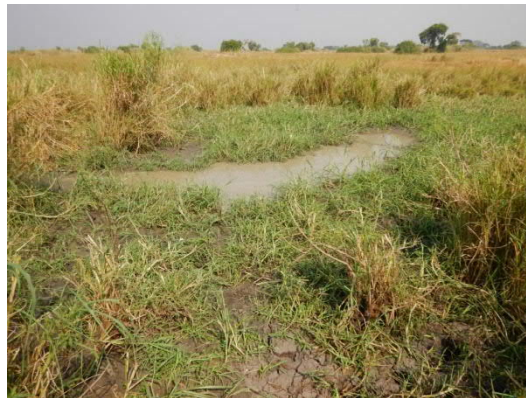
Photo A-JK-170110-608 and A-JK-170110-595 of Seasonally Flooded Grassland with habitat-specific flora

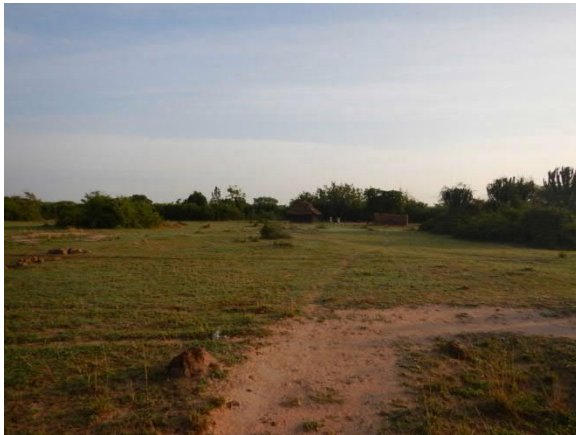
Photo A-JK-170622-704 of Modified Bushed Grassland with Thicket

This site is located on flat ground (slope 0-4°) on sandy soil. The vegetation is Modified Grassland with Thicket dominated by *Azima tetracantha* and *Euphorbia candelabrum* with short grass and sparse tree cover (Photo A-JK-170622-704). The area is mostly settled in Bushed Grassland dominated by *Hyperthelia dissoluta* with thicket dominated by *Euphorbia* and *Azima*. The tree layer is

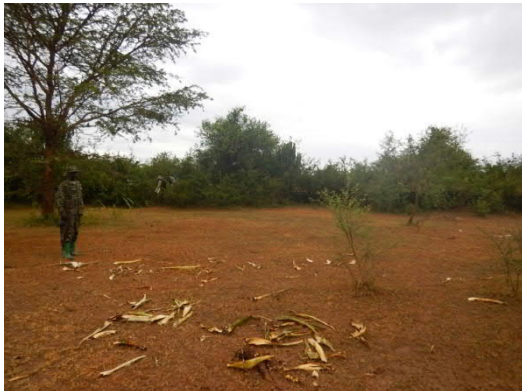
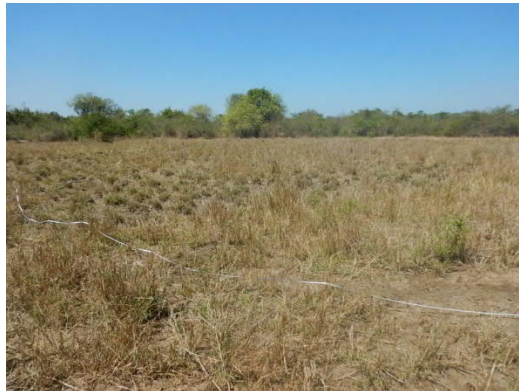
Photo A-JK-170615-612 of Bushed Grassland with Thicket (left) and A-JK-170401-167 of Seasonally Flooded Grassland fringed by Bushland (right)

There is also Seasonally Flooded Grassland with shallow depressions of impeded drainage dominated by *Setaria sphacelata* and *Cynodon dactylon* and fringed by dense *Acacia* Bushland (Photo A-JK-170401-167). In the lower lying areas is Bushland dominated by *Acacia brevispica*,

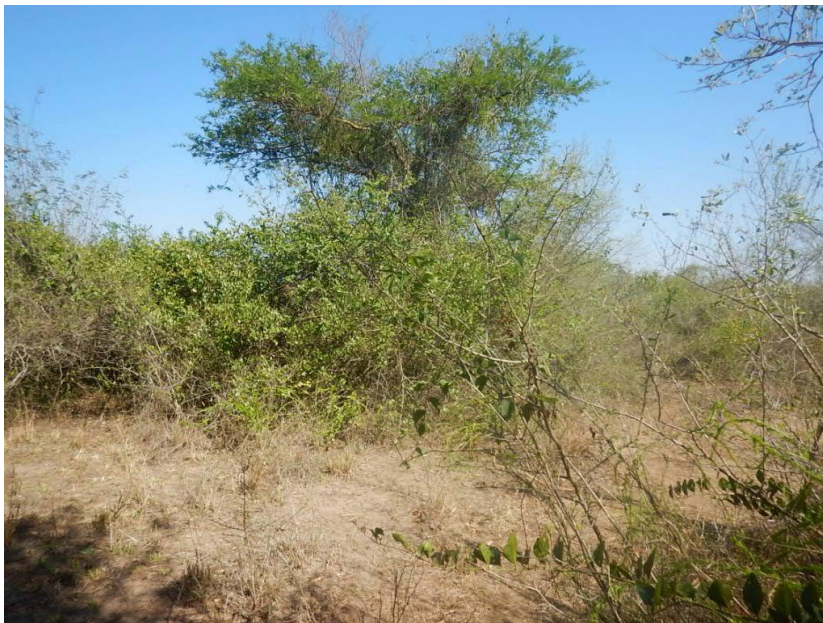
Photo A-JK-170401-166 of Bushland with bare patches

Jasminum sp., *Ziziphus pubescens* and *Capparis* spp. forming a dense impenetrable cover with sparse bare patches (Photo A-JK-170401-166).

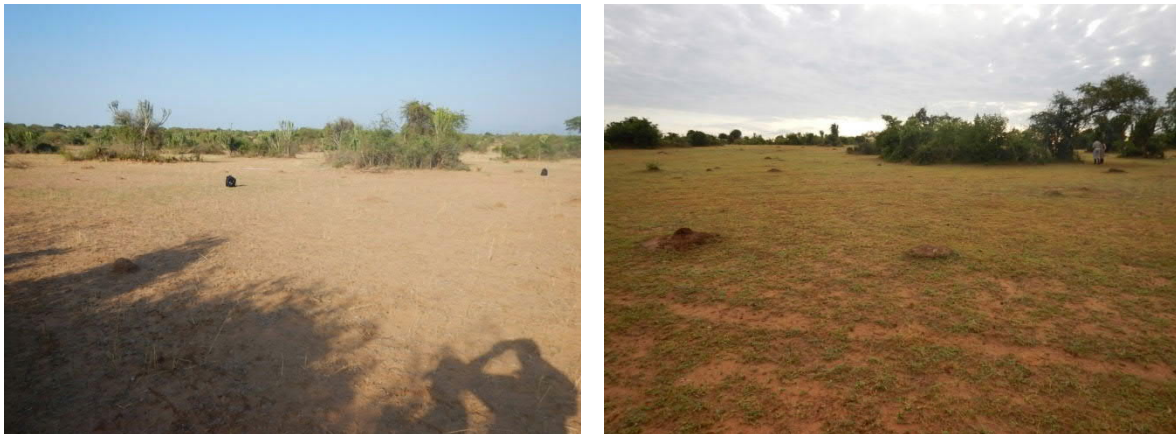
Photos A-JK-170402-173 and A-JK-170616-623 of Bushed Grassland

This site is located on flat ground on sandy soil. The vegetation is Bushed Grassland with Thicket dominated by *Euphorbia*, *Crateva*, and *Ziziphus* with very short grass and sparse tree cover (Photos A-JK-170402-173 and A-JK-170616-623). There is also Grassland with Thicket dominated by *Euphorbia* and *Cadaba* and very sparse tree cover.

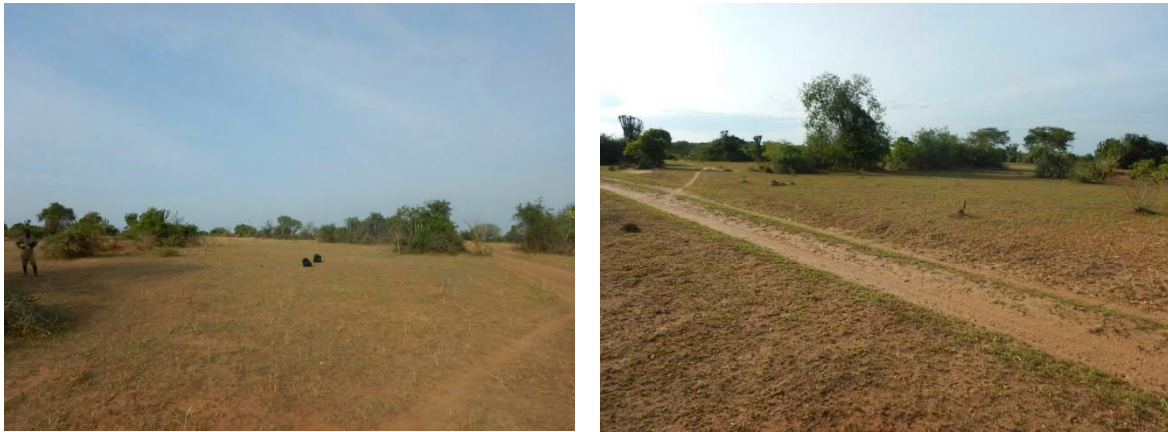
Photos A-JK-170403-188 and A-JK-170617-634 of Bushed Grassland

This site is located on gently sloping flat (slope 4-8°) on sandy soil. The vegetation is mainly Bushed Grassland with patches of Thicket dominated by *Euphorbia candelabrum*, *Acacia brevispica* and *Acalypha fruticosa* with very sparse trees dominated by *Lannea schweinfurthii* and very low grass layer due to over grazing and burning (Photo A-JK-170403-187 - A-JK-170403-188). There is also *Hyperthelia* Grassland with Thicket dominated by *Cadaba farinosa*, *Euphorbia candelabrum* and *Ziziphus pubescens* and very sparse tree cover of *Acacia sieberiana* and *Euphorbia candelabrum*.

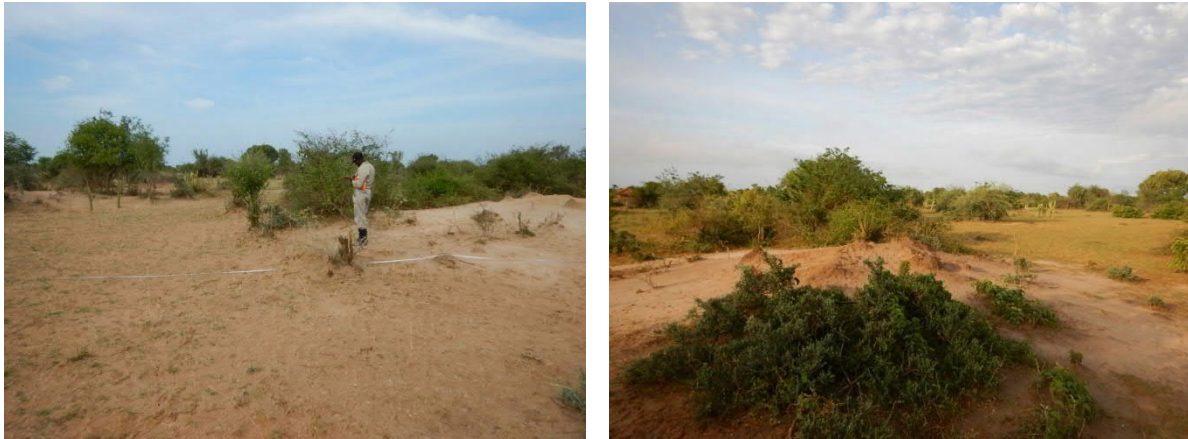
Photos A-JK-170404-201 and A-JK-170618-648 of Bushed Grassland with Thicket

This site is located on flat ground with a slope of 0-4° on sandy soil. The vegetation is Bushed Grassland with Thicket dominated by *Capparis fascicularis*, *Cadaba farinosa*, *Acacia brevispica* and *Euphorbia candelabrum* with very short grass of *Hyperthelia dissoluta*, *Digitaria longiflora* in the herbaceous layer (Photos A-JK-170404-201 and A-JK-170618-648). There is also Grassland with sparse thicket dominated by *Cadaba farinosa* and sparse tree cover dominated by *Euphorbia candelabrum* and *Lannea schweinfurthii*.

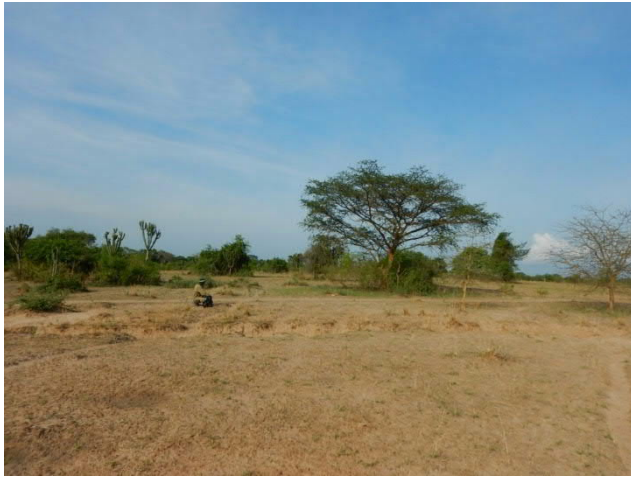
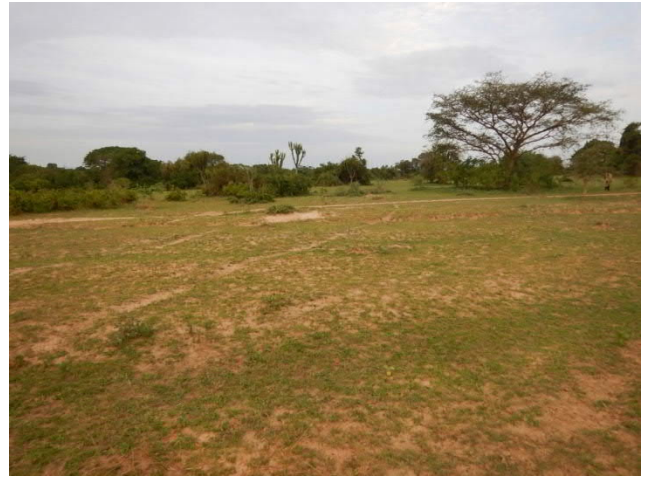
Photos A-JK-170406-224 and A-JK-170620-675 of Bushed Grassland with Thicket

This site is located on gently sloping ground with a slope angle of 8-16° on sandy soil. The vegetation is Bushed Grassland with Scattered Thicket of *Euphorbia candelabrum*, *Ziziphus pubescens* and very sparse tree cover of *Crateva adansonii* and *Acacia sieberiana* with very short grass (Photos A-JK-170406-224 and A-JK-170620-675). Some of the areas are Modified Bushed Grassland with patches of woodlots and sparse tree cover dominated by *Euphorbia candelabrum*, *Lannea schweinfurthii*.

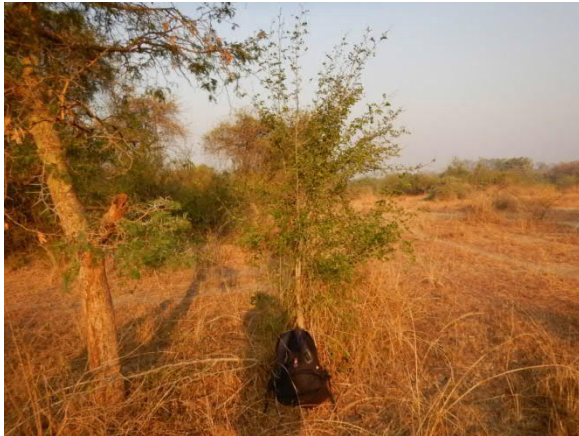
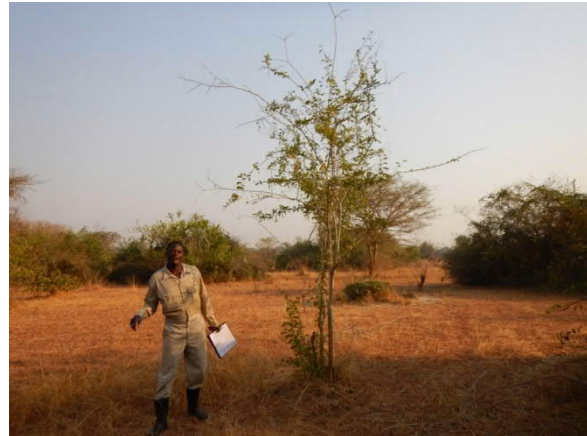
Photos A-JK-170120-925 (left) and A-JK-170120-930 (right) of Globally Threatened *Dalbergia melanoxyton* in the centre of each photo

Dalbergia melanoxyton (Photos A-JK-170120-925, A-JK-170120-930), a Globally Threatened species, was recorded at areas shown in the table below within the site. This is assessed as Globally LR/NT (IUCN 2017) and as nationally NT in Uganda by WCS (2016). *Thevetia peruviana* is an exotic recorded at very low abundance. Invasive *Cassia siamea* was also recorded from the site.

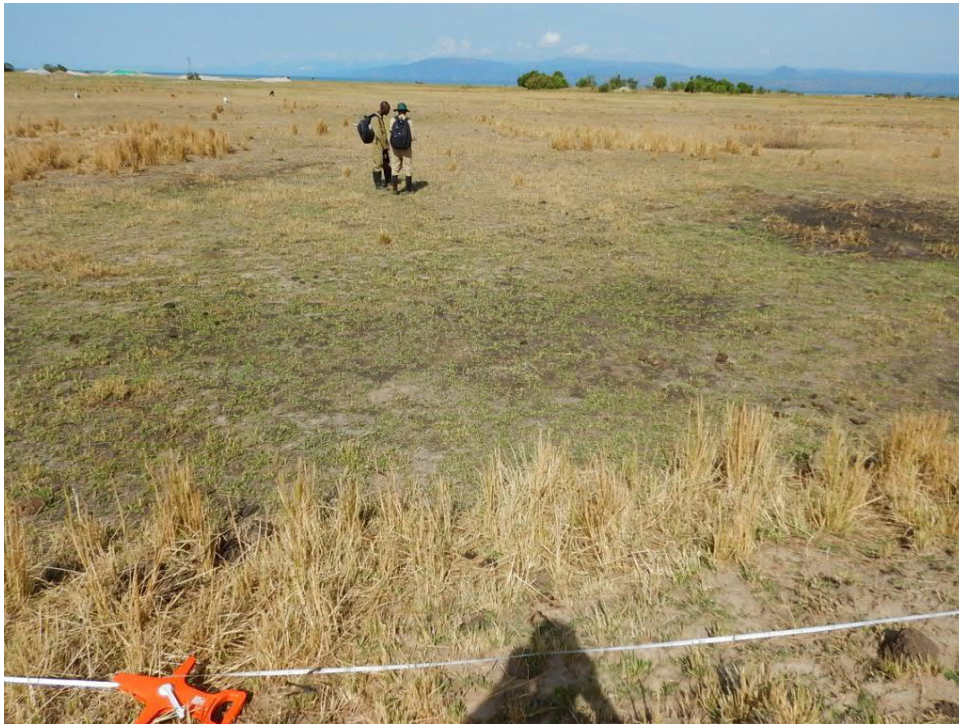
Photo A-JK-170329-087 of Floodplain on sandy soil

This site is located on the shores of Lake Albert on a flat (slope 0-4°) floodplain on sandy soil (Photo A-JK-170329-087). The vegetation is Seasonally Flooded Grassland with very short grass dominated by *Paspalidium geminatum*, *Cynodon dactylon* and in places with and *Sporobolus pyramidalis* and bare sandy patches. There is also Permanent wetland dominated by *Aeschynomene elaphroxylon*, *Typha latifolia*, *Phragmites mauritianum* with *Eichhornia crassipes* (Photos A-JK-170329-094 and A-JK-170329-096).

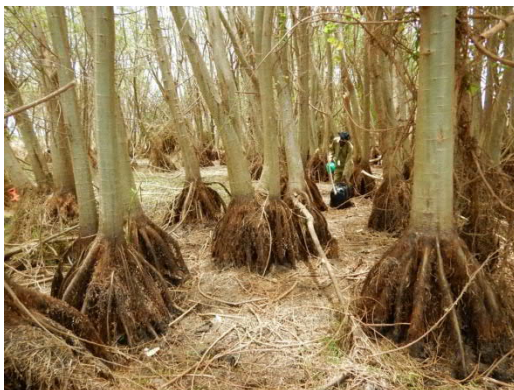
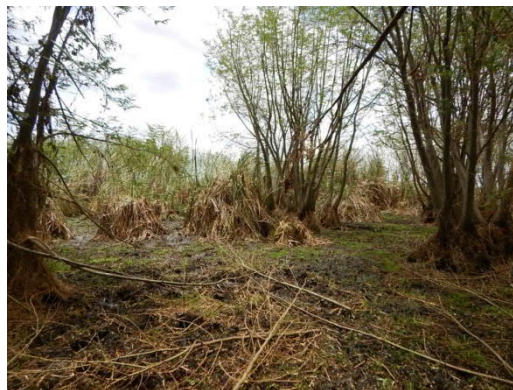
Photos A-JK-170329-094 and A-JK-170329-096 (below) of Permanent Wetland with *Aeschynomene elaphroxylon*

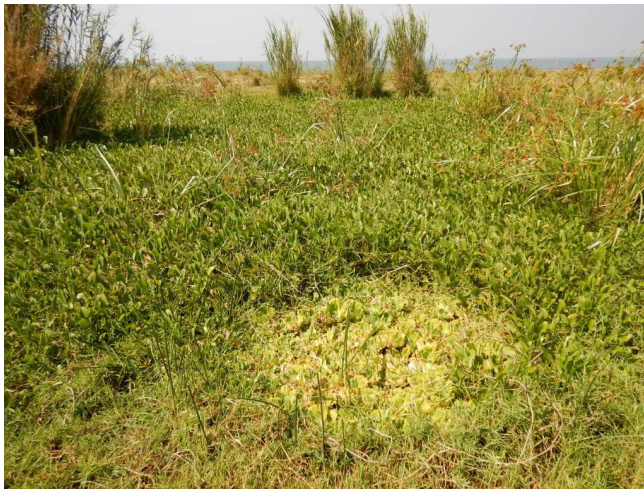
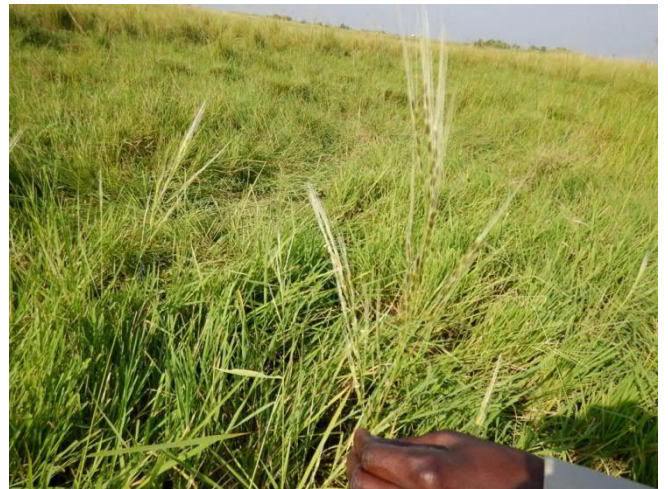
Photo A-JK-161218-531 of *Eichhornia crassipes* (left) and A-JK-161218-5 of 06 *Oryza* sp. (right)

The invasive *Eichhornia crassipes* (Photo A-JK-161218-531) may get introduced into the lake deliberately or inadvertently, rapidly increasing its abundance. Alteration of the physical conditions may compromise the survival of habitat-specific species such as *Cyperus articulatus*, *Leersia hexandra*, *Oryza*.
