TILENGA PROJECT

ENVIRONMENTAL AND SOCIAL IMPACT ASSESSMENT

Volume VI(b)

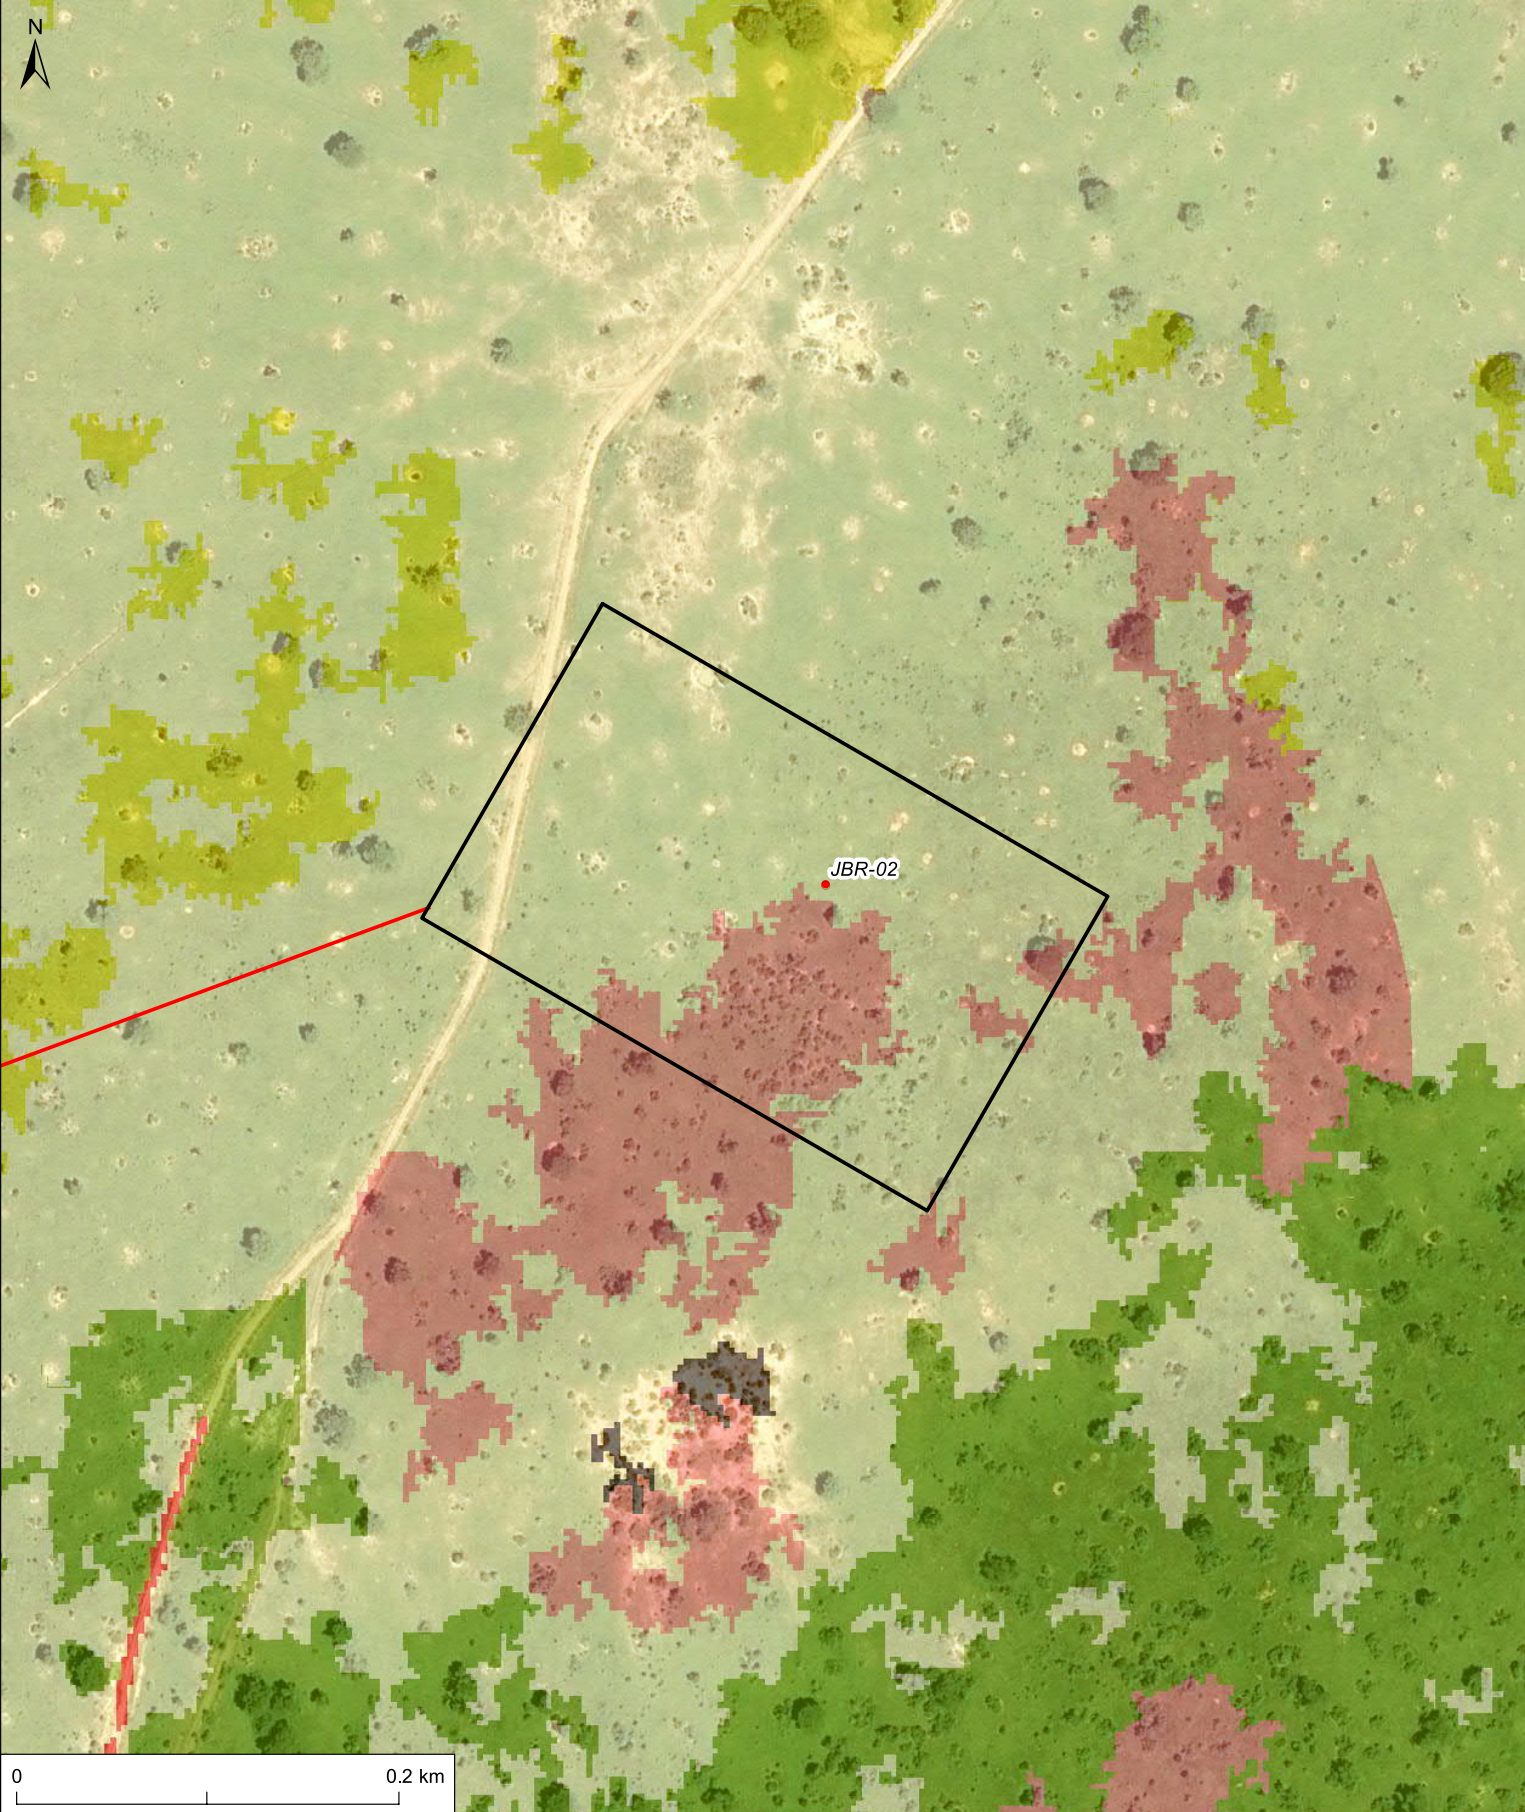
VEGETATION COVER - JBR-02

- Wellpad location
 - ▭ Wellpad Extent - Maximum
 - Production and Injection Network
- | Land Cover Class (WCS 2017) | |

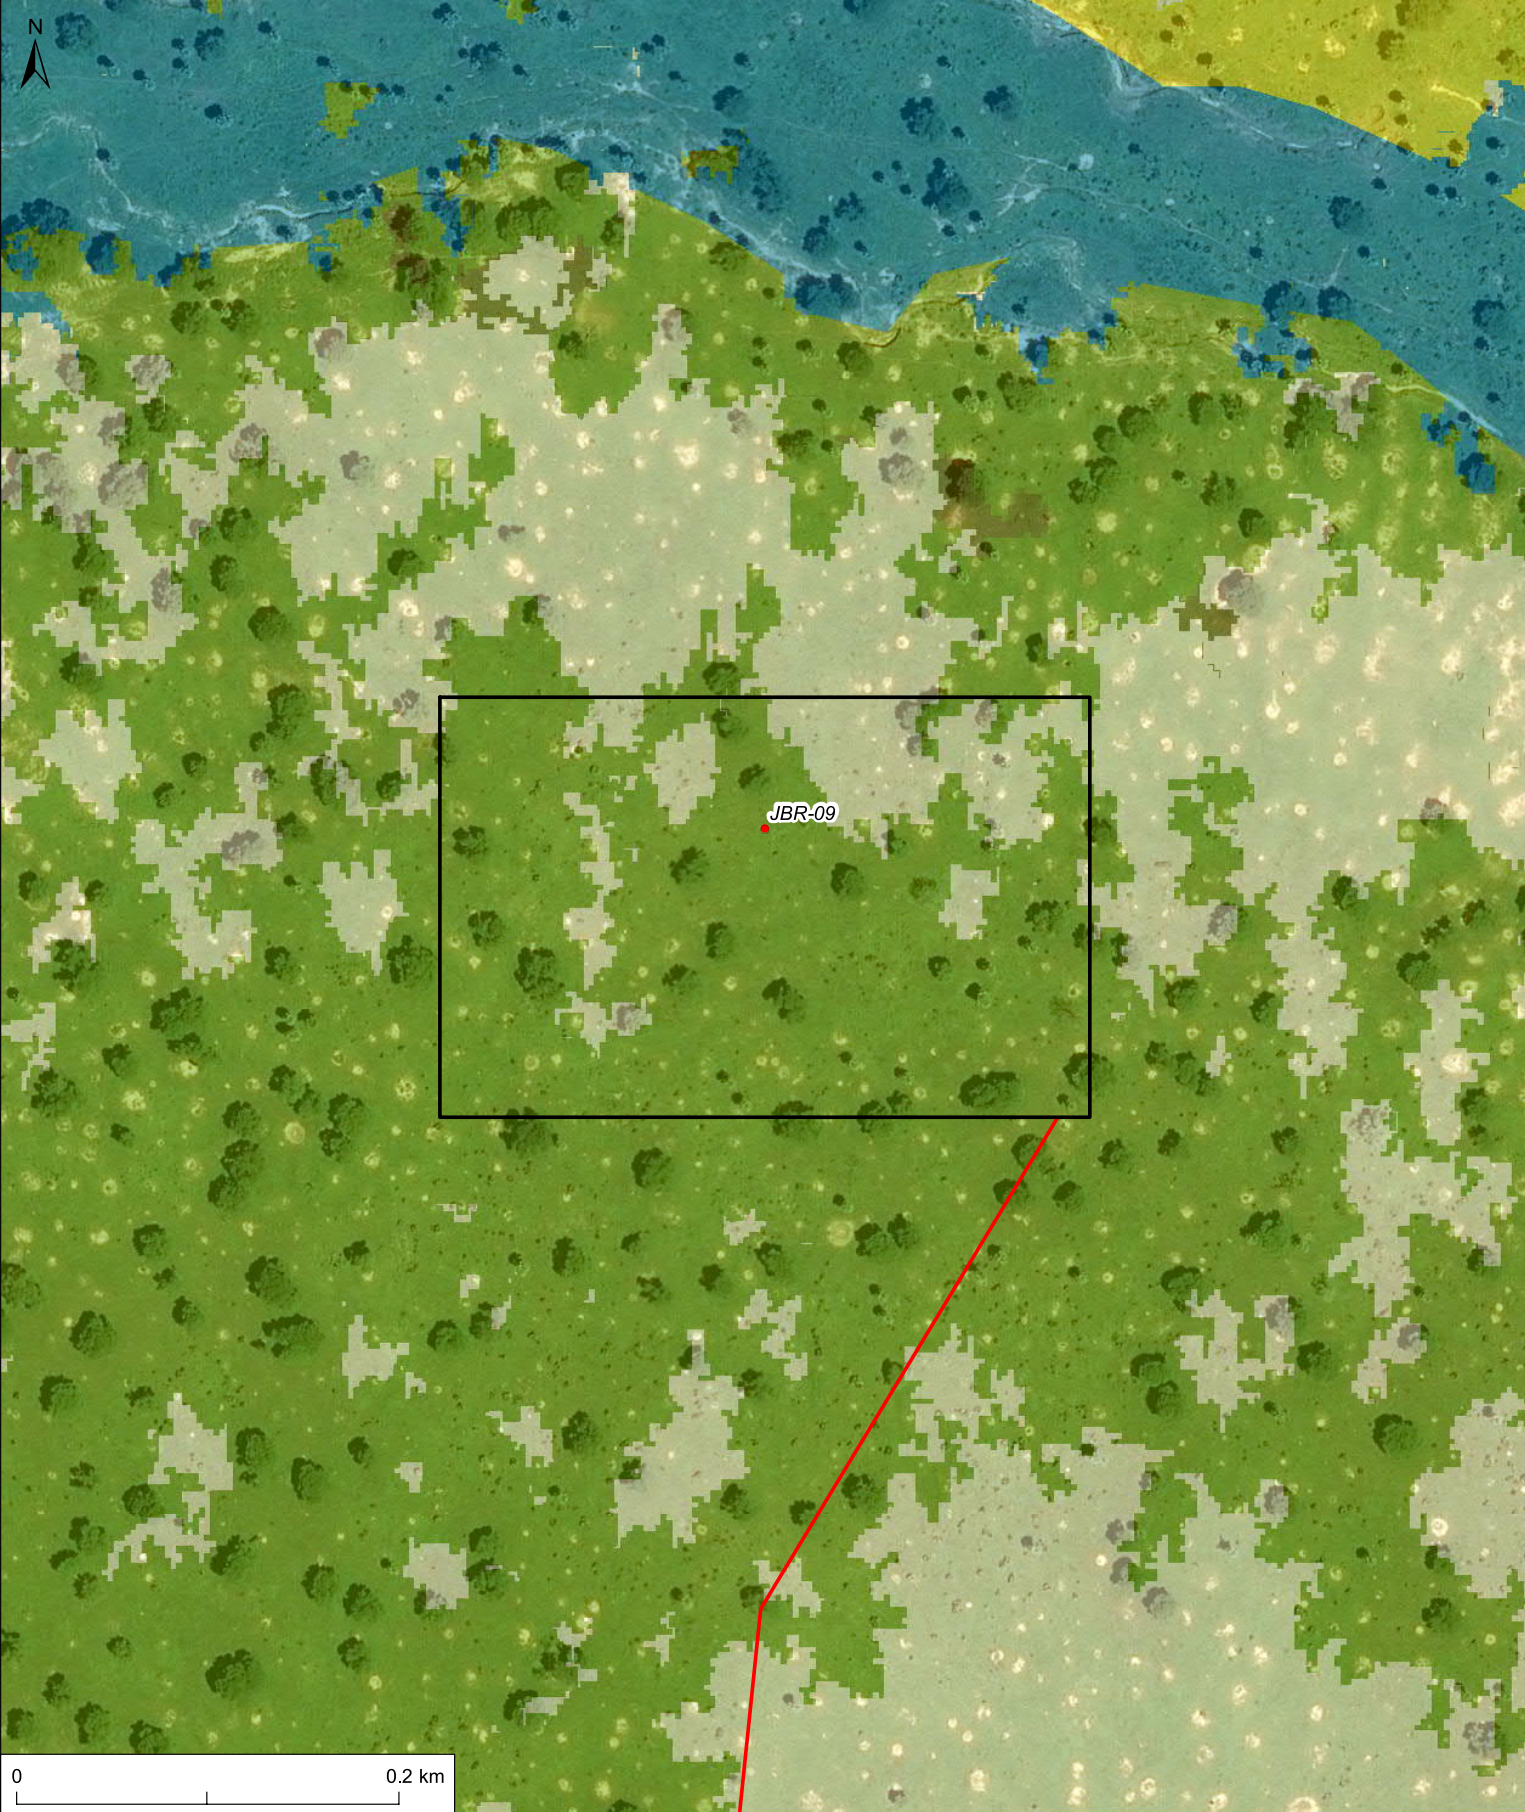
VEGETATION COVER - JBR-09

- Wellpad location
 - ▭ Wellpad Extent - Maximum
 - Production and Injection Network
- | Land Cover Class (WCS 2017) | |
