Machine: Hydraulic system / 88-01-01 / CRANE #1 - HYDRAULICS

Diagnosis date: 30 april 2013

Oil : Total Equivis ZS 46

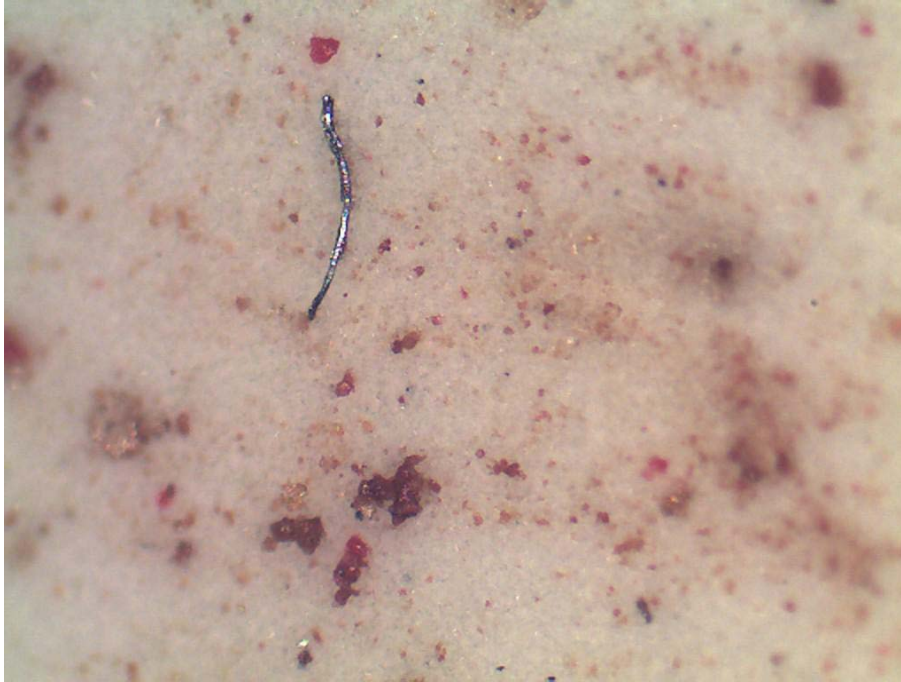
1 cm = 52 µm

- The 5 microns filtration shows :
- Metallic chips -
- Varnish -
- Oxydation products -
- The oil change will have eliminated the contamination.
- Monitor thoroughly the evolution.
